PHOTOGRAPHIC SURVEY OF THE LDEF MISSION

NASA Special Publication 531

Robert L. O'Neal

National Aeronautics and
Space Administration

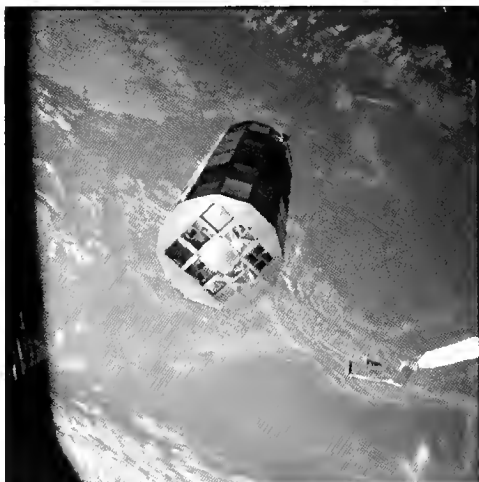
Figure 22
Photo No.: S32-85-008
Dup. Neg. No.: L90-10468
LISAR No.: EL-1994-00102
Photo Credit: JSC
Photo Date: 1/12/90
Location: In Flight
Subject: Capture of LDEF

Figure 22 (In Flight). This figure shows the space end of the LDEF as *Columbia* descended with the RMS poised to complete the capture maneuver. The Earth and clouds are in the background. Note the extensive damage to the thermal covers of experiment M0001. The aft flight deck window frame obscures an area along the left side of the photograph.

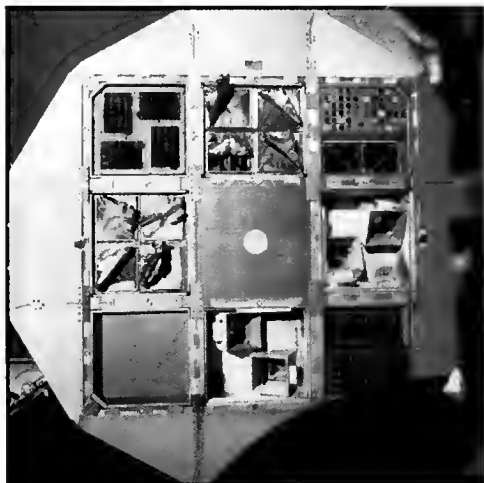
Figure 24 (In Flight). This view shows the space end of the LDEF during berthing in the cargo bay of the orbiter with the RMS. Note the damage to the thermal covers of the experiment M0001 and the prominent brown discolorations on other experiment hardware.

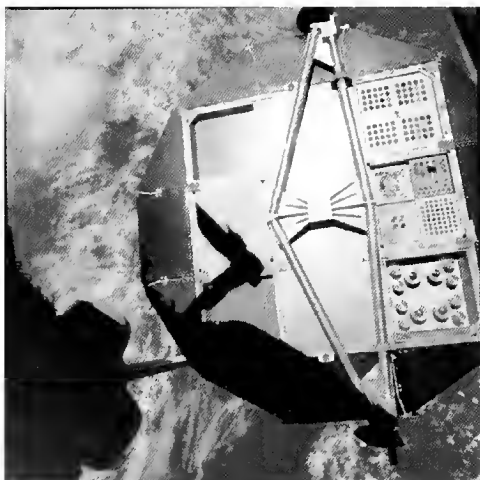
Figure 26 (In Flight). This view shows the Earth-facing end of the LDEF on the RMS with the cloud cover of the Earth as background. Note the brown discolorations on several of the painted surfaces of the experiments. The orbiter, in the lower left corner of the photograph, is in the shadow of the LDEF. There is a shadow of the RMS across the left portion of the photograph.

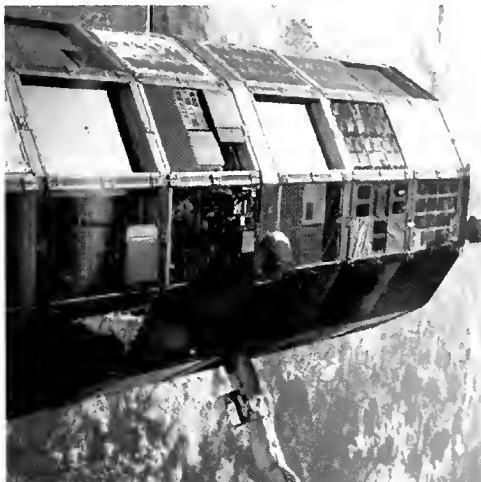
Figure 28 (In Flight). This close-up side view shows bays A through E in rows 2 through 5 with the LDEF on the RMS. Direct sun and reflections caused some experiment details in row 4 to be washed out, while low light levels caused a lack of detail in other rows. Wrinkles in the thermal screens in tray B3 are prominent. The thermal covers of trays of experiment AO178 in row 5 show reflections of the Earth and the sky.

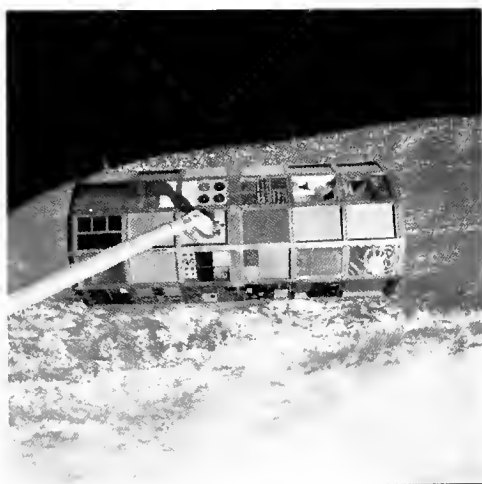
Figure 34 (In Flight). This wide-angle view shows bays A through F in rows 11, 12, and 1 through 3 with the LDEF on the RMS against a background of the Earth and clouds. The aft flight deck window frame obscures the upper part of the photograph. Note the clean appearance of the white paint in row 12 compared with similar paint on experiment hardware in rows 2 and 3. The original bright yellow paint on the trunnion scuff plates on row 3 has darkened significantly.

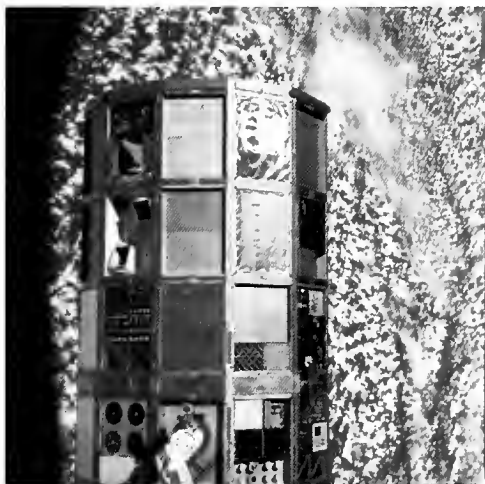
Figure 35 (In Flight). This side view shows bays C through F in rows 11, 12, and 1 through 3 with the LDEF on the RMS. The aft flight deck window frame forms a shadow on the left edge of the photograph. The Earth with a cloud cover provides the background. Note the clean appearance of the white paint on the thermal covers in row 12 when compared with similar paint on the hardware in rows 2 and 3. The white paint dots on the experiment tray clamp blocks on row 12 appear clean; however, the dots darken progressively as row 3 is approached. The original bright yellow paint on the trunnion scuff plates on row 3 has darkened significantly.

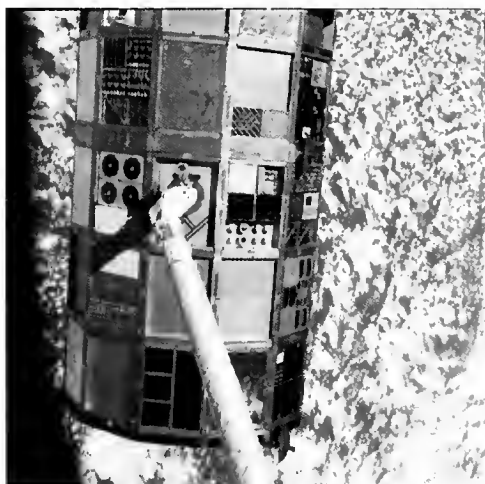
Figure 36 (In Flight). This side view shows bays A through D in rows 11, 12, and 1 through 3 with the LDEF on the RMS. The aft flight deck window frame forms a shadow on the left edge of the photograph and the Earth with a cloud cover provides the background. Note the clean appearance of the white paint on the thermal covers in row 12 when compared with similar paint on experiment hardware in rows 2 and 3. The original bright yellow paint on the trunnion scuff plates on row 3 has darkened significantly.

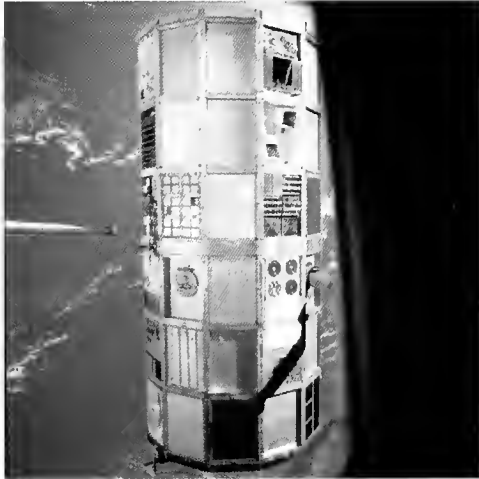
Figure 37 (In Flight). This figure shows a side view of bays A through F in rows 9 through 12 and 1 with the LDEF on the RMS. The orbiter vertical stabilizer protrudes from the left edge of the photograph. The right side of the photograph is obscured by the frame of the aft flight deck window. The peculiar light pattern in the trays in row 11 and the variations along the row indicate that the cargo bay lights were on.

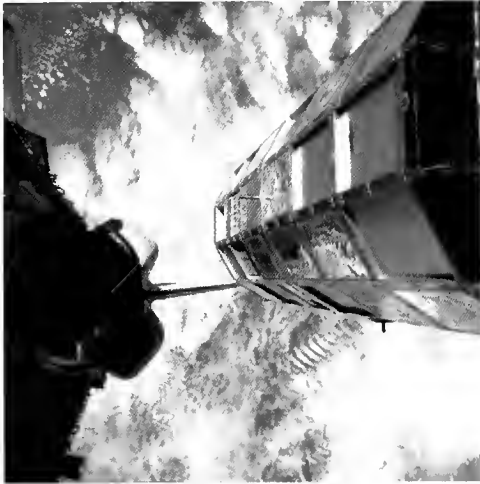
Figure 39 (In Flight). This view shows bays A through F in rows 4 through 7 with the LDEF on the RMS. The orbiter is in the left of the photograph and the Earth with a cloud cover is visible in the background. The reflections of the sky and clouds are visible in the thermal covers of the trays of experiment AO178.

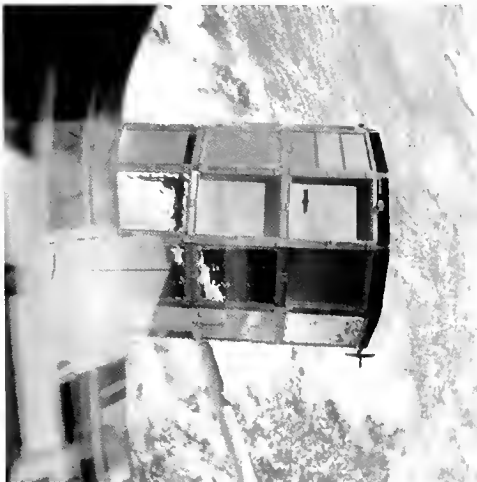
Figure 40 (In Flight). This side view shows bays A through C in rows 4 through 7 with the LDEF on the RMS. The bright pink in the left of the photograph is a reflection of the cargo bay liner in the viewing window. The aft flight window frame is also visible in the left of the photograph. The Earth, sky, and clouds are visible in the background. Reflections show in the thermal covers of the trays of experiment AO178. An overall blue tint was probably caused by reflections of the sky below.

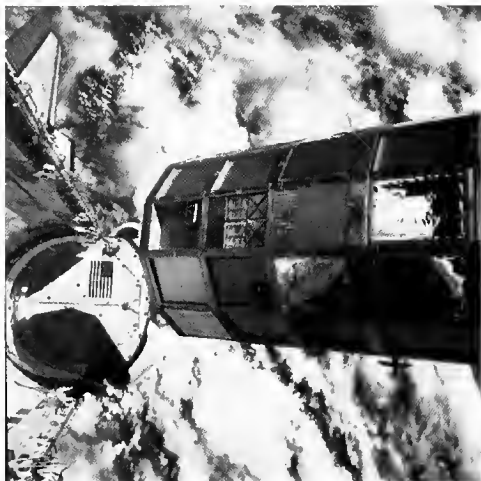
Figure 41 (In Flight). This side view shows bays C through F in rows 4 through 7 with the LDEF on the RMS. The cargo bay of the orbiter is visible in the left of the photograph and the Earth and clouds are in the background. The photograph is dark because of the very shallow lighting angle. Reflections of the clouds and the sky are evident in the thermal covers of the trays of experiment AO178.

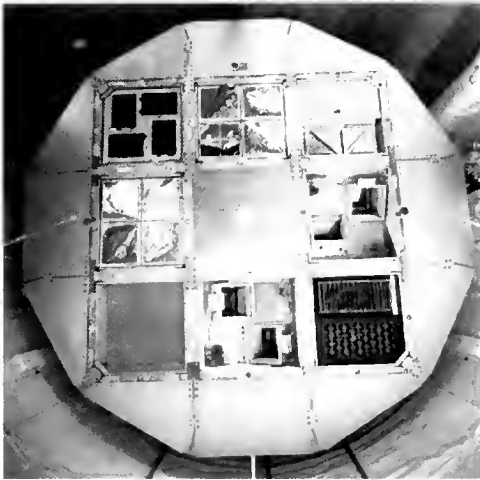
Figure 43 (Postflight). This view of the space end of the LDEF was taken from the cargo bay access hatch after the *Columbia* landed at Edwards Air Force Base, California. The cargo bay liner is visible in the bottom of the photograph. The radiators, which are located on the inside of the orbiter payload bay doors, are visible in the top. The three yellow balls on the aluminum support rods (whiskers) that are fixed in the cargo bay were used for berthing the LDEF during retrieval operations. A brown discoloration appears to be spread over the surface of the space end of the LDEF. This discoloration appears to be lighter on the anodized aluminum thermal panel surfaces and darker on the experiment surfaces that were coated with the Chemglaze A276 white thermal control paint. The discoloration on the uncoated aluminum hardware (such as the end frame splice plates) is also darker. The amber and red reflectors seem to have little apparent degradation.

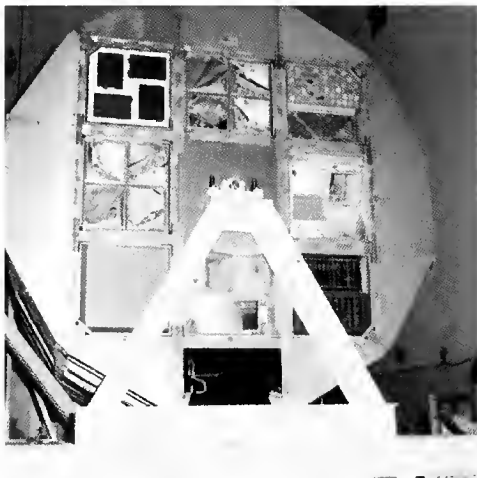
Figure 46 (Postflight). This postflight view is of the space end of the LDEF in the SAEF II. The discoloration in the areas of trays H6 and H9 (containing experiment AO038) and the damage to the thermal covers of experiment M0001 in trays H3 and H12 are evident. Note that the thermal panel below tray H6 has been removed.

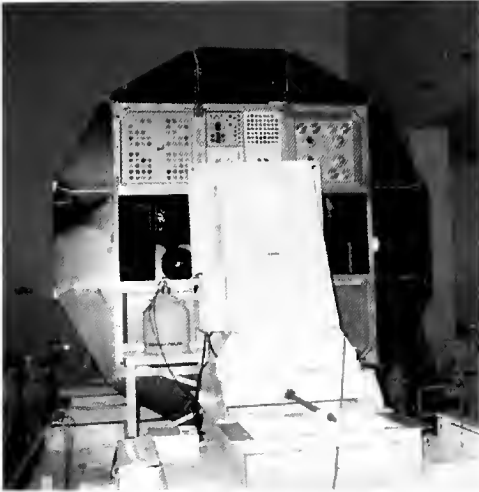
Figure 47 (Postflight). This postflight view is of the Earth end of the LDEF in the SAEF II. Some discoloration of the thermal panels on the left side of the photograph is visible. This area was affected by the end support beam in flight, which was removed when this photograph was made. The canister on the stand adjacent to tray G8 was part of the instrumentation setup for radiation measurements.

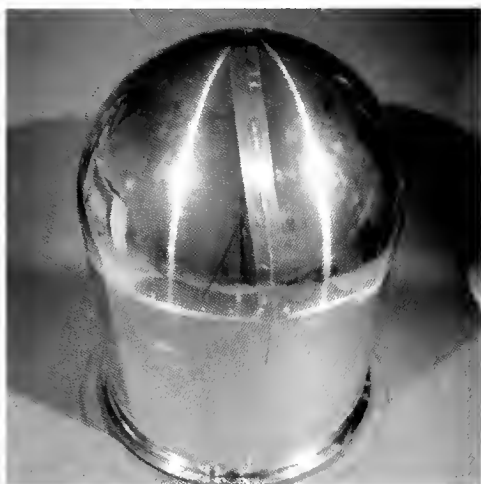
Figure 62 (Postflight). This view is of the magnetic damper protective shroud after removal from the LDEF. This shroud protected the damper from any particles that could be attracted by the strong magnet and affect the stability of the LDEF. Note the protective tape over the temperature sensor electrical lead.

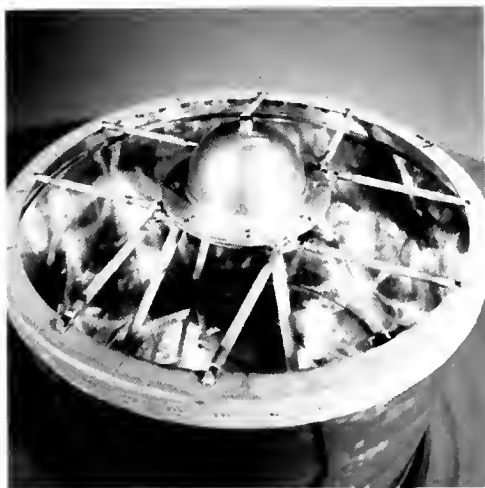
Figure 63 (Postflight). This photograph is of the magnetically anchored viscous damper after removal from the LDEF. The bolts that fastened the damper to the fiberglass support structure have been removed. The damper had a gold coating for thermal control in flight.

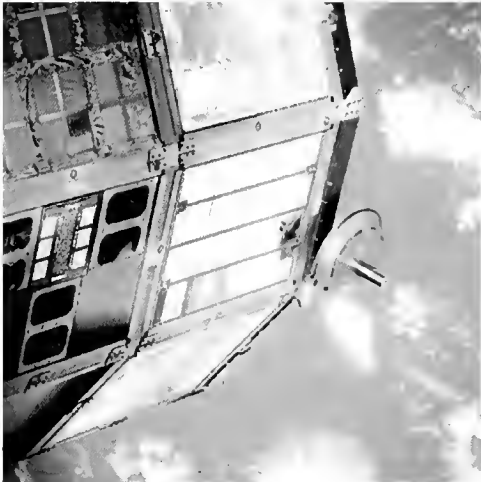
Figure 73 (In Flight). In this photograph, tray A2 is located in the lower row. The thermal cover is without visible damage; however, it is more taut than in the prelaunch photograph. The wrinkled spots on the thermal cover are over areas where Velcro pads are bonded to the back of the cover. The rippled effect around the cover edges occurs between the attachment pads.

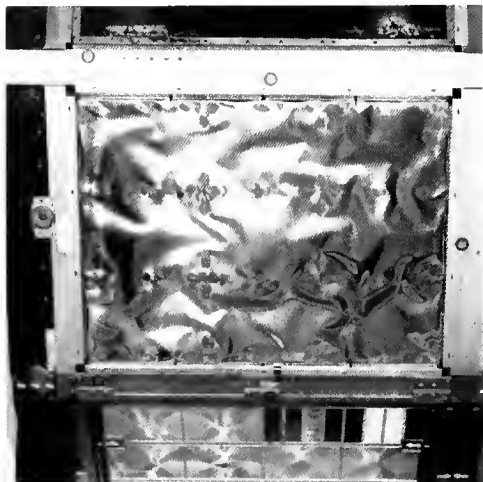
Figure 74 (Postflight). The thermal cover appears to be specular and undamaged. It is less taut than in the in-flight photograph. The uniformly located oval spots on the thermal cover are areas where Velcro pads attach the thermal cover to the support frame; these spots are more visible than in the prelaunch photograph. The scallop effect around the cover edges occurs between the attachment pads and shows the upper edge of the support frame. The ground strap appears to be in place with no visible damage, although it is darker.

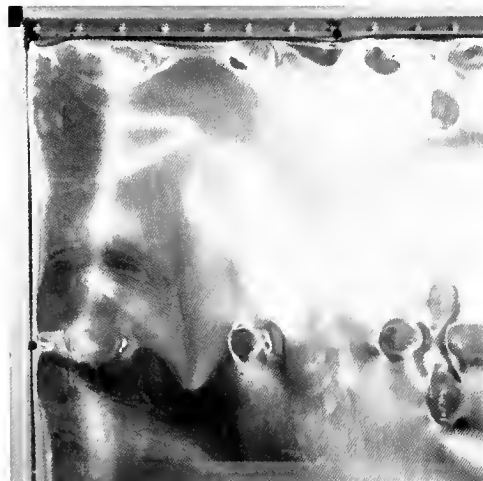
Figure 75 (Postflight). This close-up photograph of the upper left one-sixth of the tray shows a faint pattern of marks similar to brush marks in a top-to-bottom direction. This pattern is somewhat less specular than other regions. Observation of this tray during operations in the OPF and later in the SAEF II showed less specular areas on the thermal cover. Some fingerprints on the thermal cover are visible. The reflective properties of the uneven surface of the cover result in various light and color patterns.

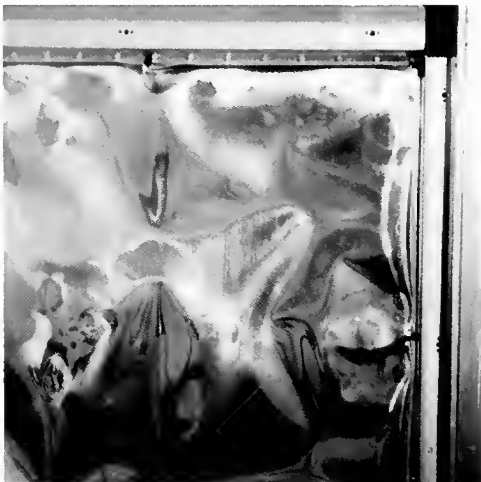
Figure 77 (Postflight). This close-up photograph of the upper right one-sixth of tray A2 shows a faint pattern of marks similar to brush marks in a top-to-bottom direction. These marks are not as prominent as in the left portions of the tray. The reflective properties of the uneven surface of the cover result in various light and color patterns.

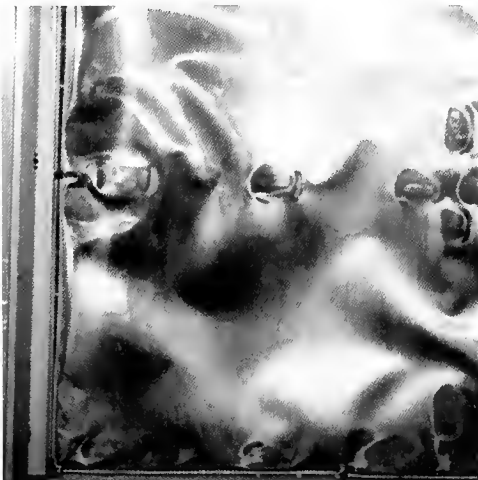
Figure 78 (Postflight). This close-up photograph of the lower left one-sixth of tray A2 shows a pattern of marks similar to brush marks in a top-to-bottom direction. The light area in the upper right is a reflection of photographic lights. The reflective properties of the uneven surface of the cover result in various light and color patterns.

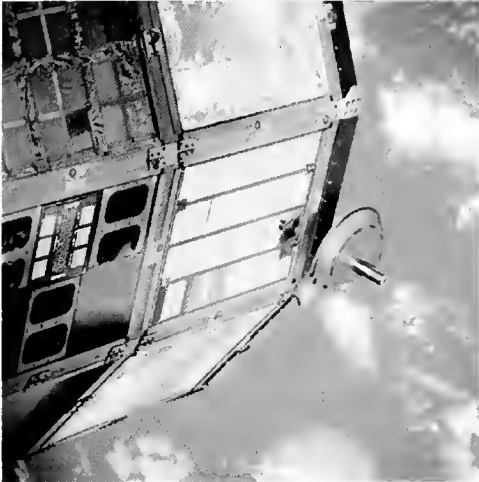
Figure 82 (In Flight). The canisters are shown in open positions in the center tray of bay A. They were expected to open about 2 weeks after launch and close about 11 months into the mission. All exposed materials are secure and no damage is evident. Contamination stain coats the tray flanges and the aluminum canister hardware. The end support beam scuff plate in the photograph was a bright yellow prior to launch, but it is now a much darker mustard yellow after space exposure.

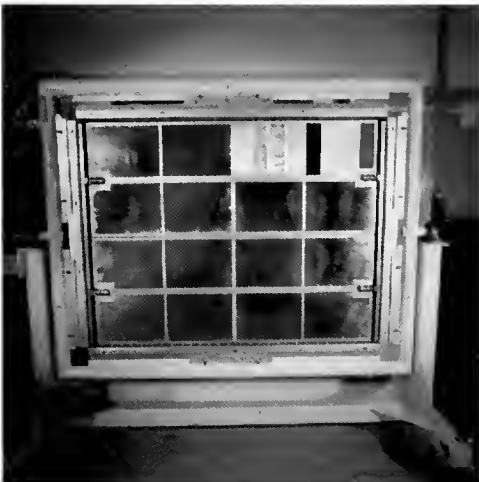
Figure 83 (Postflight). The experiment is shown in the postflight configuration before the canisters were closed with ground support equipment that bypassed the onboard electronic circuits. There is no visible damage. The reflection of a video camera on a tripod and light sources are visible in the surfaces of the gold foil.

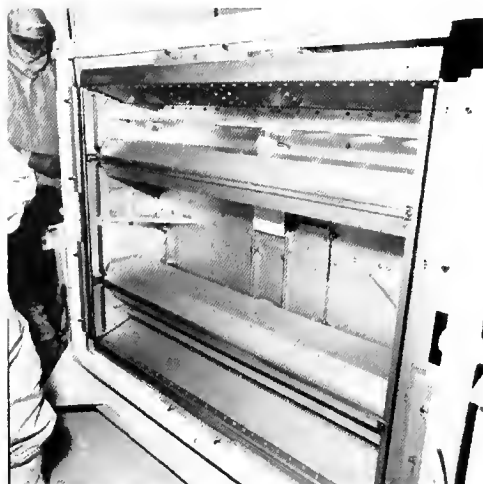
Figure 84 (Postflight). The experiment canisters are shown after being closed by ground support equipment. The experiment hardware has no damage.

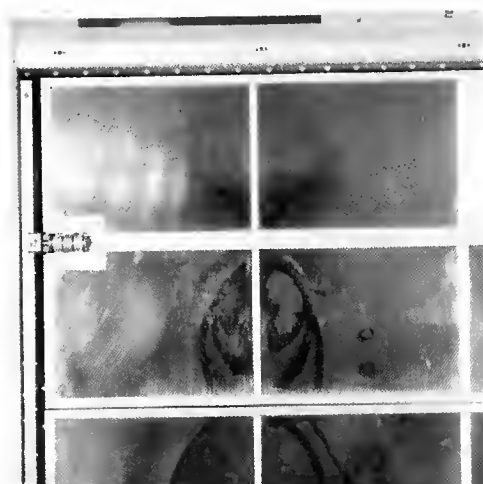
Figure 85 (Postflight). This photograph of the upper left one-fourth of the tray shows light and room reflections in the gold foil. The foil appears to be in preflight condition.

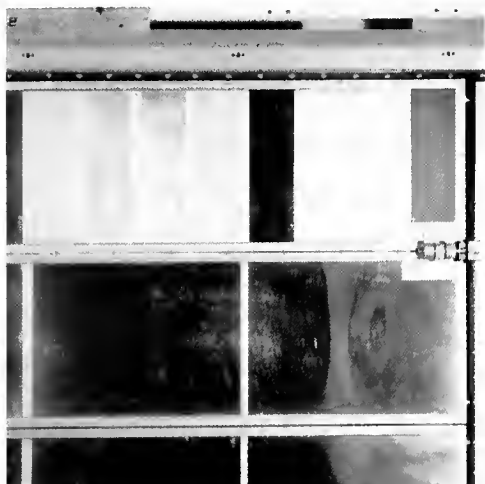
Figure 86 (Postflight). This photograph of the upper right one-fourth of the tray shows light and room reflections in the highly reflective gold foil. The foil appears to be in preflight condition. Photographic lights washed-out details of the test strips along the top of the tray.

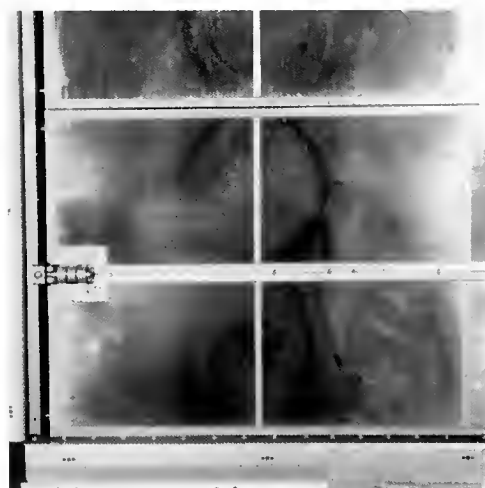
Figure 87 (Postflight). This photograph of the lower left one-fourth of the tray shows light and room reflections in the highly reflective gold foil. The foil appears to be in preflight condition.

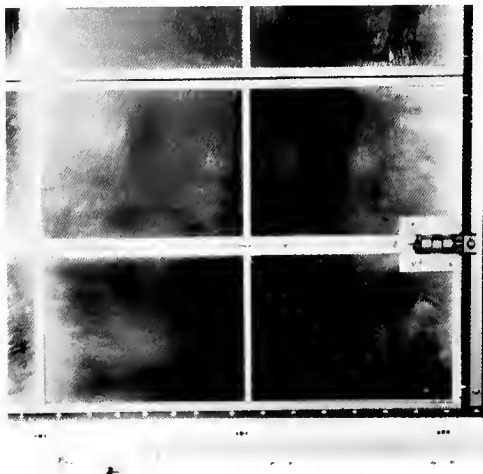
Figure 88 (Postflight). This photograph of the lower right one-fourth of the tray shows light and room reflections in the highly reflective gold foil. The green is a reflection of the clean room garments that were worn by nearby personnel. The foil appears to be in preflight condition.

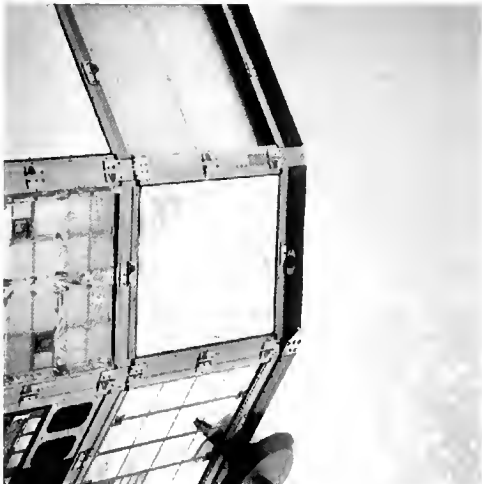
Figure 89 (In Flight). The thermal cover appears to be specular and undamaged, but it is more taut than in the prelaunch photograph. The wrinkled spots on the thermal cover are areas where Velcro pads are bonded to the back of the cover. The scalloped effect around the cover edges occurs between the attachment pads. The ground strap appears to be in place and to have no visible damage.

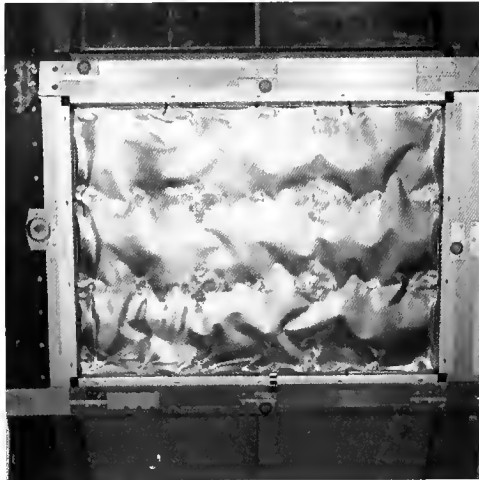
Figure 90 (Postflight). The thermal cover appears to be specular and undamaged. It appears less taut than in the in-flight photograph. The uniformly located oval spots on the thermal cover are areas where Velcro pads attached the thermal cover to the support frame. These attachment pads are more visible than in the prelaunch photograph. The scallop effect around the cover edges occurs between the attachment pads and shows the upper edge of the support frame. The ground strap appears to be in place with no visible damage.

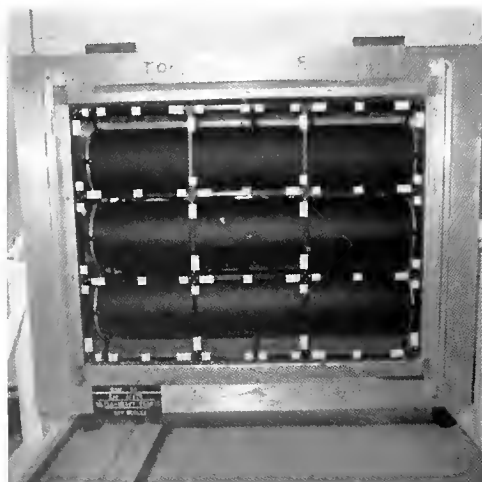
Figure 91 (Postflight). This postflight photograph was taken in SAEF II after the silvered Teflon thermal cover had been removed. All experiment hardware appears to be in prelaunch condition and to be securely in place. The three cylindrical pressure vessels that contain the experiment detectors are shown mounted in the experiment tray. The frame for mounting the thermal cover is in the foreground. The white rectangles on the frame are Velcro pads bonded to the frame for attaching the thermal cover. The Velcro pads are in excellent condition. The top half of the cylinders and the thermal cover frame were painted black to meet thermal control requirements.

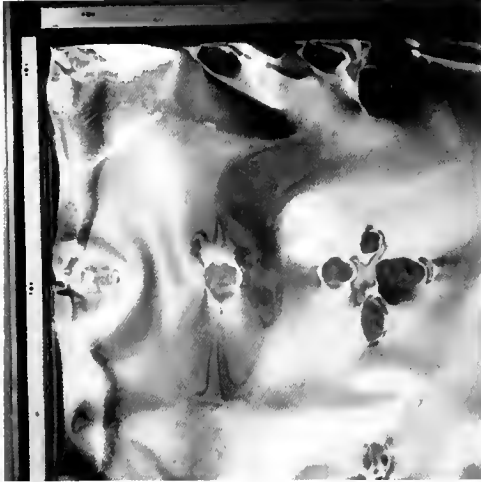
Figure 92 (Postflight). This photograph is of the upper left one-sixth of the tray. The thermal cover appears specular and undamaged. The reflective properties of the uneven surface of the cover result in various light and color patterns. The locations of the Velcro attachment pads are obvious.

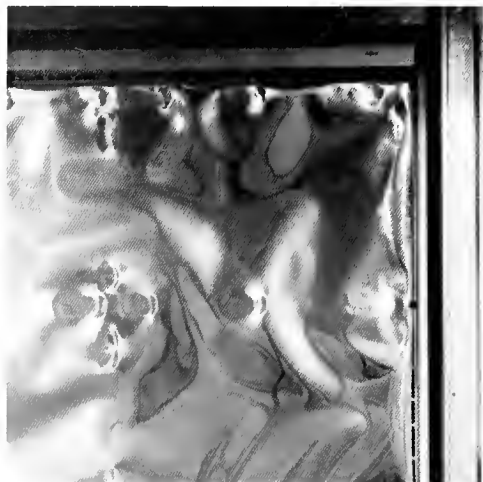
Figure 94 (Postflight). This photograph is of the upper right one-sixth of the tray. The thermal cover appears specular and undamaged. The reflective properties of the uneven surface of the cover result in various light and color patterns. The locations of the Velcro attachment pads are obvious.

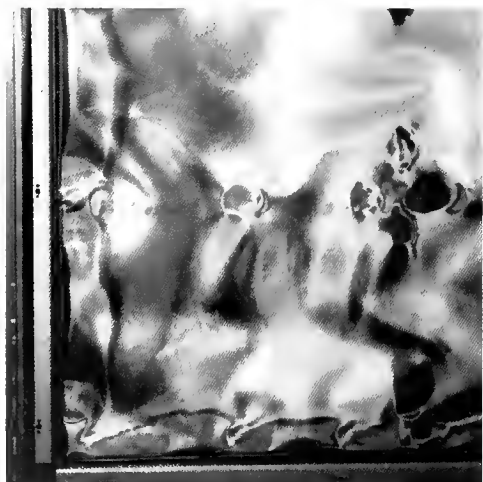
Figure 95 (Postflight). This photograph is of the lower left one-sixth of the tray. The thermal cover appears specular and undamaged. The reflective properties of the uneven surface of the cover result in various light and color patterns. The locations of the Velcro attachment pads are obvious.

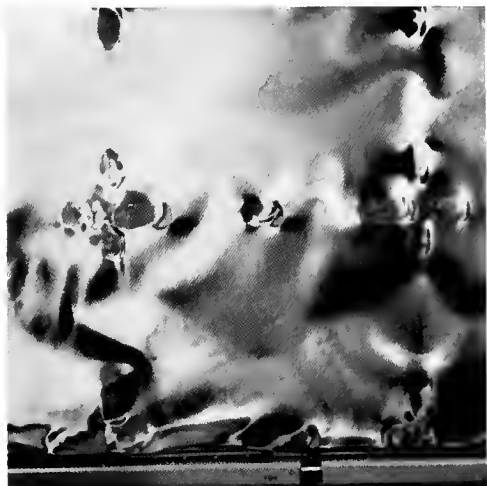
Figure 96
Photo No.: KSC-390C-1743.11
Dup. Neg. No.: L91-7615
LISAR No.: EL-1994-00245
Photo Credit: KSC
Photo Date: 3/8/90
Location: KSC SAEF II
Subject: Postflight Detail of Lower Center of
Tray A4

Figure 96 (Postflight). This photograph is of the lower center one-sixth of the tray. The thermal cover appears specular and undamaged. The reflective properties of the uneven surface of the cover result in various light and color patterns. The locations of the Velcro attachment pads are obvious.

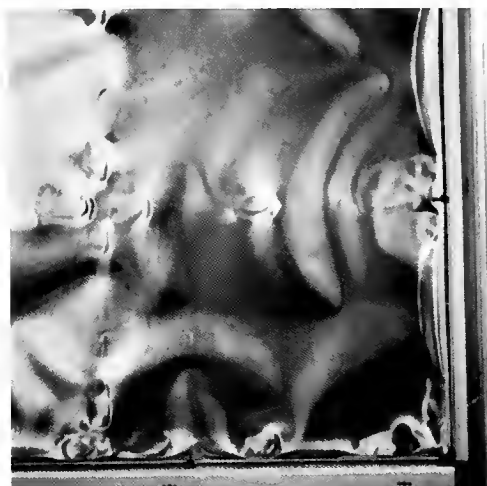
Figure 97
Photo No.: KSC-390C-1743.12
Dup. Neg. No.: L91-7616
LISAR No.: EL-1994-00246
Photo Credit: KSC
Photo Date: 3/8/90
Location: KSC SAEF II
Subject: Postflight Detail of Lower Right of
Tray A4

Figure 97 (Postflight). This photograph is of the lower right one-sixth of the tray. The thermal cover appears specular and undamaged. The reflective properties of the uneven surface of the cover result in various light and color patterns. The locations of the Velcro attachment pads are obvious.

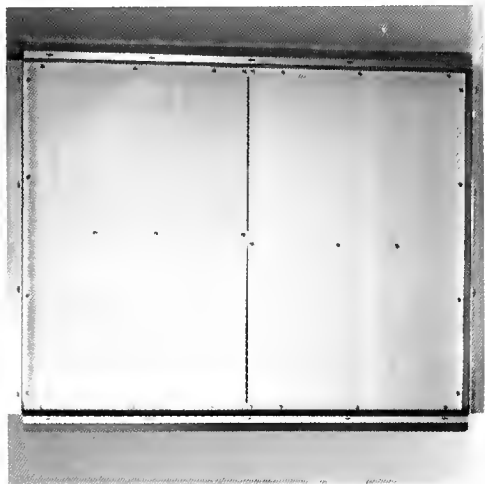
Figure 98 (Preflight). Because trays dedicated to experiment S0001 (except tray A6, which had the target for the keel camera) were not photographed prior to flight, a spare tray was photographed for descriptive purposes. Experiment S0001 consisted of two 3/16-in-thick chromic-anodized aluminum panels that were mounted in a 3-in-deep peripheral tray. The panel had two coatings: a thin layer of chromic anodization that faced the exterior and a Chemglaze-306 black paint that faced the interior. Both coatings contributed significantly to thermal control of the LDEF. The pink and greenish-gray tints and the vertical stripes on the two debris panels were by-products of the chromic anodization coating process. The anodization appears to make surface features or markings more visible.

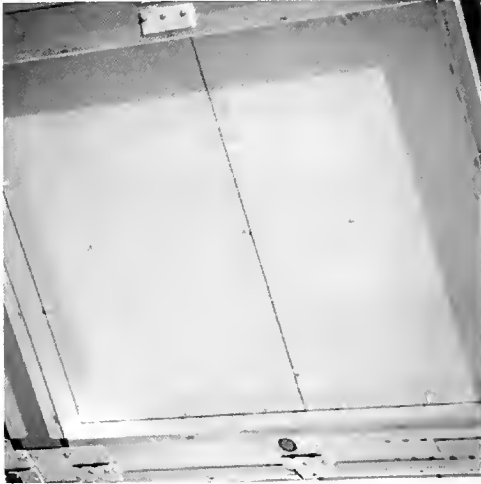
Figure 99
Photo No.: S32-76-079
Dup. Neg. No.: L90-10395
LISAR No.: EL-1994-00059
Photo Credit: JSC
Photo Date: 1/12/90
Location: In Flight
Subject: In-Flight Survey of Tray A5

Figure 99 (In Flight). Fingerprints that were observed on the lower tray flange and the sidewall indicate the lack of proper preflight handling and cleaning. The greenish-gray and pink tints on the two debris panels are by-products of the chromic anodization coating process and are not attributed to contamination or exposure to the space environment.

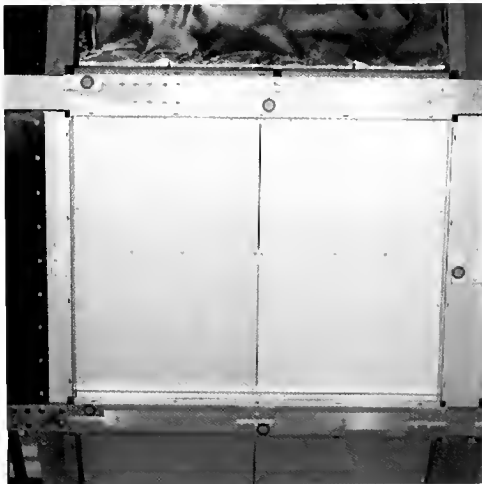
Figure 100
Photo No.: KSC-390C-1035.09
Dup. Neg.: L90-13454
LISAR No.: EL-1994-00185
Photo Credit: KSC
Photo Date: 2/9/90
Location: KSC SAEF II
Subject: Postflight Survey of Tray A5

Figure 100 (Postflight). The greenish-gray and pink tints on the two debris panels are by-products of the chromic anodization coating process and are not attributed to contamination or exposure to the space environment. The fingerprints along the edges of the left panel that were observed in the in-flight photograph are still visible. Those visible previously along the top edges have been washed out by the lighting. The light band along the sides and across the bottom of the panels is caused by light reflecting from the tray sidewalls.

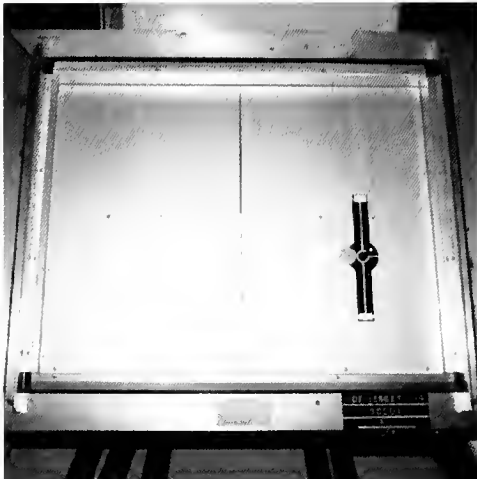
Figure 101 (Preflight). This tray is typical of the other 18 trays dedicated to experiment S0001 except for the target for the Shuttle keel camera and the reflector. The target and the reflector were visual aids for berthing the LDEF during retrieval. This photograph of tray A6 and the photograph of the spare flight tray shown in figure 98 can be used to judge the preflight appearance of the witness plates for experiment S0001. The greenish-gray and pink tints are by-products of the chromic anodization coating process. The line pattern is due to the rolling mill operation during manufacturing. The anodization makes such surface features more visible.

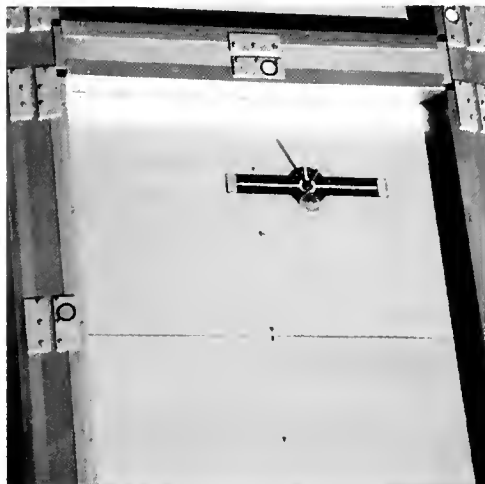
Figure 102
Photo No.: S32-76-087
Dup. Neg. No.: L90-10396
LISAR No.: EL-1994-00060
Photo Credit: JSC
Photo Date: 1/12/90
Location: In Flight
Subject: In-Flight Survey of Tray A6

Figure 102 (In Flight). The pink and greenish-gray tints and the horizontal stripes on the two debris panels are by-products of the chromic anodization coating process and are not attributed to exposure to the space environment. The blue is due to lighting and is not a true change in surface color. The brown irregular discolorations along the center edges of the debris panels appear to be fingerprints from prelaunch handling. The black unit located on the top panel is a target for the keel camera that was used during the berthing of the LDEF. The stripes and the tip of the vertical rod of the target for the keel camera appear darker than in the prelaunch photograph. The light band across the top panel is reflected light from the tray sidewall and the dark band down the right side of the panels is a shadow from the tray sidewall.

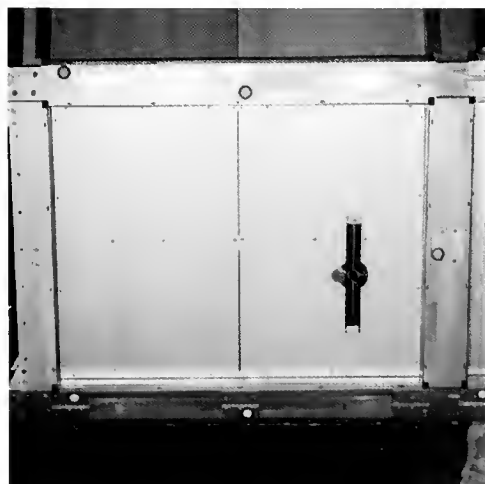
Figure 103
Photo No.: KSC-390C-1035.03
Dup. Neg. No.: L90-13448
LISAR No.: EL-1994-00181
Photo Credit: KSC
Photo Date: 2/9/90
Location: KSC SAEF II
Subject: Postflight Survey of Tray A6

Figure 103 (Postflight). The pink and the greenish-gray tints on the two debris panels are by-products of the chromic anodization coating process and are not attributed to contamination or exposure to the space environment. The fingerprints along the center edges of the debris panels that were observed in the in-flight photograph are still visible. The vertical streaks on the debris panels appear to be the same as on the prelaunch photograph. The stripes and the tip of the vertical rod of the target for the keel camera appear darker than in the prelaunch photograph. The light band along the right side and across the bottom of the panels is caused by light reflecting from the tray sidewalls.

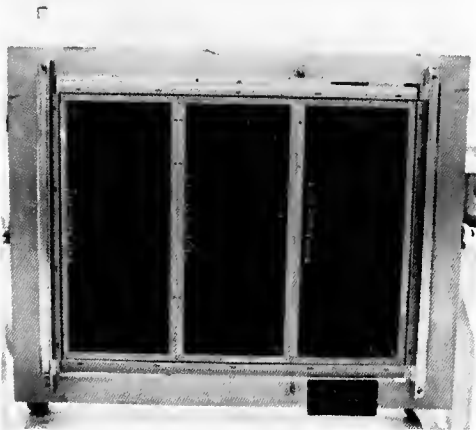
Figure 104 (Preflight). The experiment in this tray consisted of three graphite-polyimide laminate panels and associated mounting hardware. Each panel occupied one-third of the LDEF tray: a PMR-15 precured graphite-polyimide panel (T40T30060-009) was in the right one-third section, an F-178/T300 cocured graphite-polyimide panel (T40T30060-005) was in the center one-third section, and an F-178/T300 precured graphite-polyimide panel (T40T30060-001) was in the left one-third section of the tray. Each panel was identified with yellow markings. The dull gold-colored coating has been scraped from the aluminum mounting strip near the upper left tray corner. The PMR-15 panel is a uniform dark brown. The panel has several off-white marks in the lower right corner. Light grayish-brown discolorations are visible behind the identification number and behind the off-white marks. The F178/T300 cocured panel is dark brown. The F178/300 precured panel is dark brown and appears to have a lighter brown area along the vertical center, which extends from the bottom to the top of the panel.

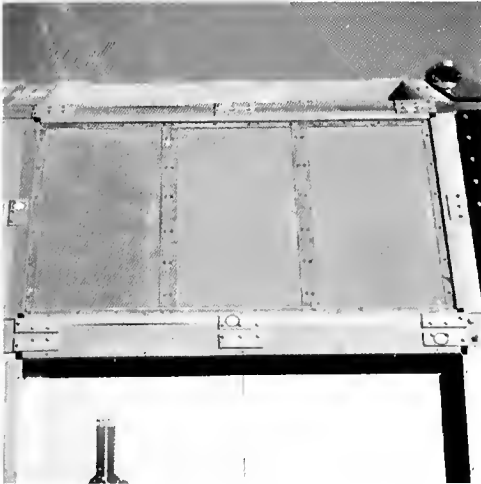
Figure 105
Photo No.: S32-76-095
Dup. Neg. No.: L90-10398
LISAR No.: EL-1994-00061
Photo Credit: JSC
Photo Date: 1/12/90
Location: In Flight
Subject: In-Flight Survey of Tray A7

Figure 105 (In Flight). In this photograph, the dull gold-colored coating that was observed on the aluminum mounting strips in the preflight photograph has turned to a medium brown. The yellow numbers seem darker than in prelaunch conditions, but the white markings appear the same. There seems to be fine horizontal lines, cracks, and crazing on the surface of each panel. The PMR-15 panel on the left appears to have changed from brown (at prelaunch) to light gray. A geometric pattern, probably from the laminating process, is visible on the surface. Scratch marks and abrasions on the lower left edge of panel were on the preflight photographs. The F-178/T300 cocured panel in the center seems to have changed from dark brown to light gray. The F-178/T300 precured panel on the right appears to have changed from dark brown with a lighter brown area along the vertical center to a uniform light gray.

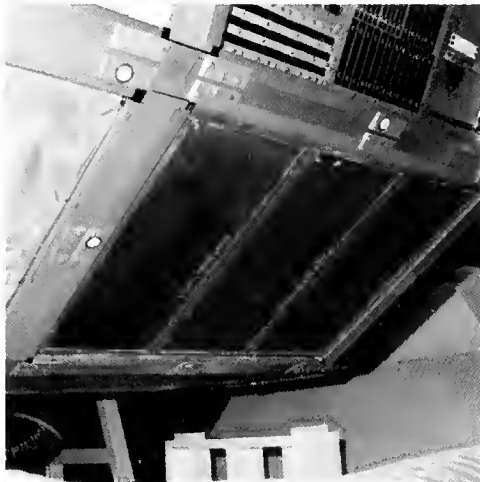
Figure 106
 Photo No.: KSC-390C-725.04
 Dup. Neg. No.: L92-17551
 LISAR No.: EL-1994-00163
 Photo Credit: KSC
 Photo Date: 2/1/90
 Location: KSC O & C building
 Subject: Postflight Survey of Tray A7

Figure 106 (Postflight). The areas on the aluminum mounting strips where the coating has been scraped or abraded can be seen in greater detail under the better lighting in this photograph. The coating color remains essentially the same. The yellow numbers seem to be a little lighter than in the in-flight photograph, but the white markings appear unchanged. The fine horizontal lines, cracks, and crazing are still visible on the surface of the panels. The PMR-15 panel on the left seems to have a gray haze over the gray brown surface. The scratch marks and abrasions on the lower left edge of the panel were on the preflight photographs. The geometric pattern visible in the in-flight photograph is not visible in this photograph. The F-178/T300 cocured panel in the center appears to have changed from the light gray in the in-flight photograph to a brownish gray. The F-178/T300 precured panel on the right seems to have changed to a brownish gray from the light gray visible in the in-flight photograph.

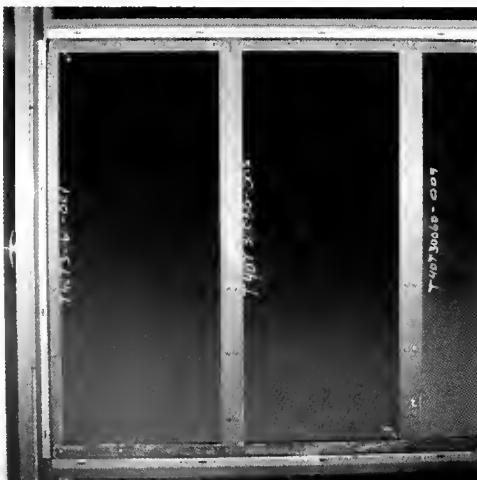
Figure 107
 Photo No.: KSC-390C-2145.10
 Dup. Neg. No.: L91-7659
 LISAR No.: EL-1994-00503
 Photo Credit: KSC
 Photo Date: 3/21/90
 Location: KSC SAEF II
 Subject: Postflight Detail of Tray A7

Figure 107 (Postflight). This close-up photograph is of the two left panels (F-178/T300 precured and F-178/T300 cocured). The yellow numbers appear lighter than in the in-flight photograph. The fine horizontal lines, cracks, and crazing are still visible on the panel surface. The F-178/T300 precured panel seems to have changed to a brownish gray from the light gray visible in the in-flight photograph. The F-178/T300 cocured panel appears to have changed from the light gray in the in-flight photograph to a brownish gray.

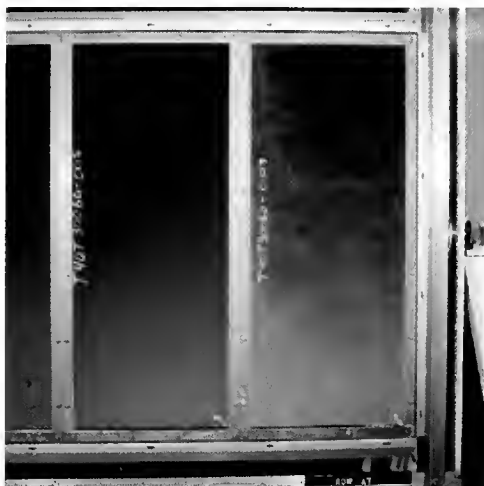
Figure 108
Photo No. KSC-390C-2145.11
Dup. Neg. No.: L91-7660
LISAR No.: EL-1994-00504
Photo Credit: KSC
Photo Date: 3/21/90
Location: KSC SAEF II
Subject: Postflight Detail of Tray A7

Figure 108 (Postflight). This close-up is of panels F-178/T300 cocured and PMR-15. The yellow identification numbers appear lighter. The fine horizontal lines, cracks, and crazing are still visible on the surface of each panel. The F-178/T300 cocured panel seems to have changed from the light gray in the in-flight photograph to a brownish gray. The geometric pattern visible on the PMR-15 panel in flight is not visible in this photograph. A gray haze or dust appears to cover the gray brown panel surface. Scratch marks and abrasions on the lower left edge of the panel were on preflight photographs.

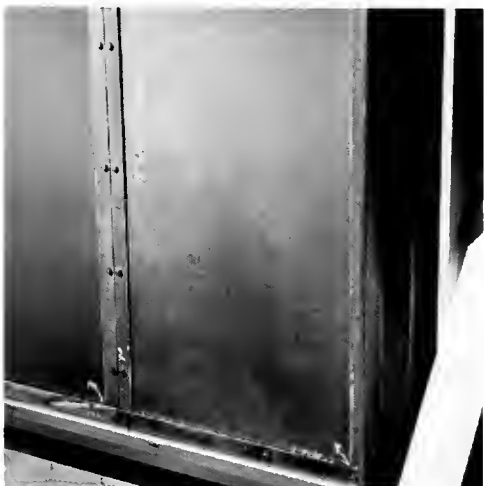
Figure 109
Photo No.: KSC-390C-2145.12
Dup. Neg. No.: L91-7661
LISAR No.: EL-1994-00505
Photo Credit: KSC
Photo Date: 3/21/90
Location: KSC SAEF II
Subject: Postflight Detail of Tray A7

Figure 109 (Postflight). This close-up photograph of the PMR-15 panel shows the geometric interference pattern that is visible when viewed from an oblique angle.

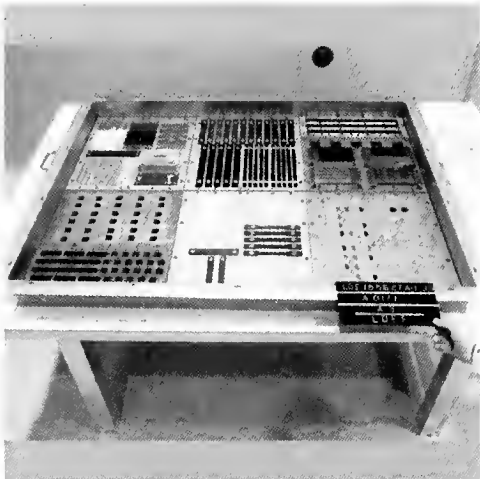
Figure 110 (Preflight). Six plates of passive components, provided by various organizations and designated plates I through VI, were mounted in the tray. Plate I, located in the upper right corner, consisted of a combination of solar cells with and without covers, solar cell modules, and solar arrays assembled on the baseplate. Plate II, located in the upper center section, had 27 composite samples (carbon fiber and glass fiber) mounted on the baseplate. Plate III, in the upper left corner, consisted mostly of metallized and thin polymeric specimens (such as Kapton, Mylar, Teflon, and white Tedlar films). Plate IV, located in the lower right corner, consisted of metals and coatings mounted in an aluminum baseplate and covered with a thin aluminum coverplate that partially masked the specimen. Plate V, in the lower center, contained thermal plastics and structural film configured into tensile and shear specimen. Plate VI, in the lower left, was populated with solar cells and associated components (covers, encapsulants, and adhesives).

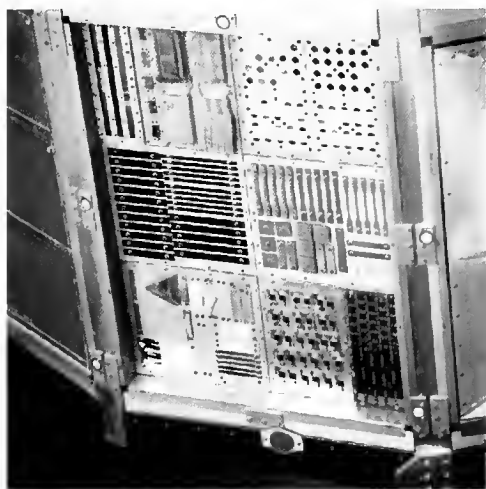
Figure 111
 Photo No.: S32-76-027
 Dup. Neg. No.: L90-10381
 LISAR No.: EL-1994-00666
 Photo Credit: JSC
 Photo Date: 1/12/90
 Location: In Flight
 Subject: In-Flight Survey of Tray A8

Figure 111 (In Flight). Plate I, in the upper left, is shown with two of the four solar arrays missing and one solar cell appears to be attached at only one corner. Other components seem to be secure. The composites on Plate II in the left center appear to have no physical damage. On Plate III, in the lower left corner of the tray, the thin films without protective coatings on the lower left corner of the plate sustained significant damage or were destroyed. The metallized film apparently survived with minimum damage. On Plate IV, in the upper right corner, several of the coatings appear to have changed to a darker color and a light brown discoloration shows around the outer edges of the mounting plate and along the right edge of the coverplates. On Plate V, in the right center, all specimens, including the tape holding down the small specimen in the lower right corner, have darkened significantly during the extended time in space. On Plate VI, in the lower right corner, the solar cell components appear to have no physical damage. The colors of the test specimens, however, seem to have darkened.

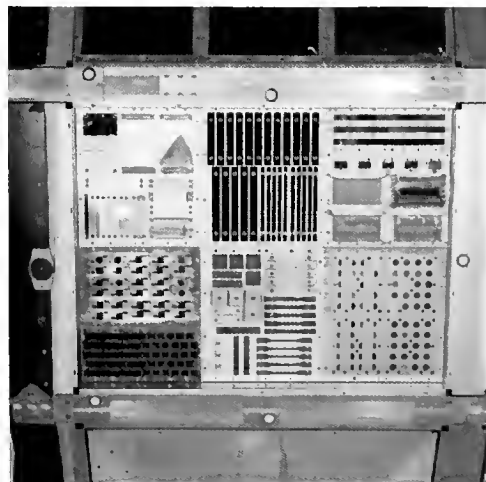
Figure 112
 Photo No.: KSC-390C-1031.12
 Dup. Neg. No.: L90-13422
 LISAR No.: EL-1994-00147
 Photo Credit: KSC
 Photo Date: 2/9/90
 Location: KSC SAEF II
 Subject: Postflight Survey of Tray A8

Figure 112 (Postflight). Most test specimens in the experiment appear to have survived intact, while the remaining specimens suffered varying degrees of deterioration. On Plate I in the upper right, three of the four solar arrays are missing. One solar array apparently was the one that was flying free near the LDEF just prior to retrieval and another was found in the Space Shuttle bay after the LDEF removal. On Plate III, in the upper left, thin films without protective coatings sustained significant damage or were destroyed.

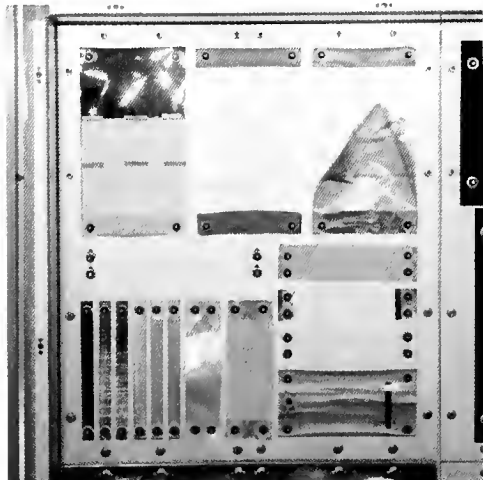
Figure 113 (Postflight). This close-up photograph of Plate III in the upper left one-sixth of the tray shows that the thin films without protective coatings sustained significant damage or were destroyed. The thin-film specimen, which is hanging by one end in the in-flight photograph, is missing. The metallized film apparently survived the mission with minimum damage.

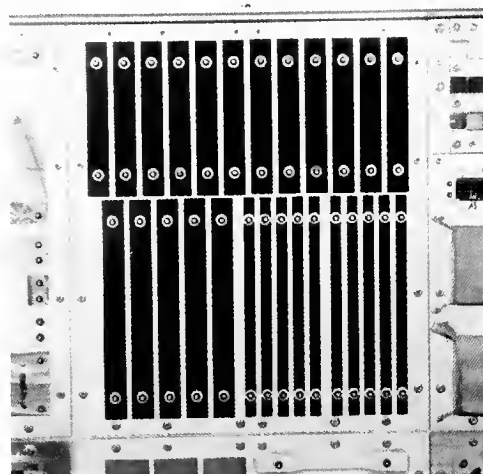
Figure 114 (Postflight). In this close-up photograph of Plate II in the upper center one-sixth of the tray, the composites appear to have no physical damage.

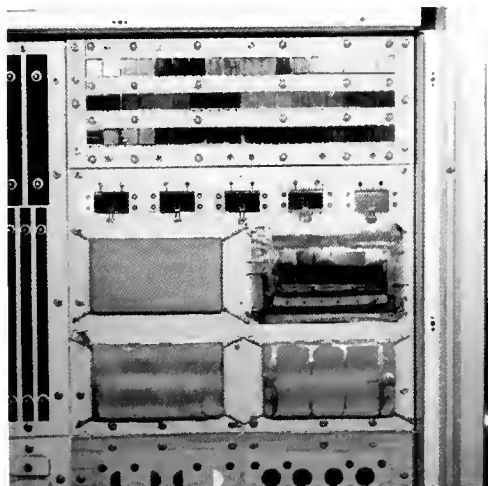
Figure 115 (Postflight). On Plate I, in the upper right corner, three of the four solar arrays are missing. One apparently was the one flying free near the LDEF just prior to retrieval. (See fig. 21.) Another was found in the Space Shuttle bay after the LDEF removal. Other components appear to be secure.

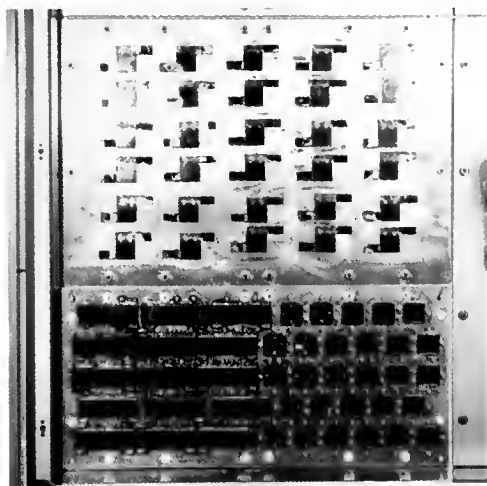
Figure 116 (Postflight). This close-up photograph of Plate VI in the lower left one-sixth of the tray shows that the solar cell components appear to be without physical damage. The colors of the specimens seem to have darkened.

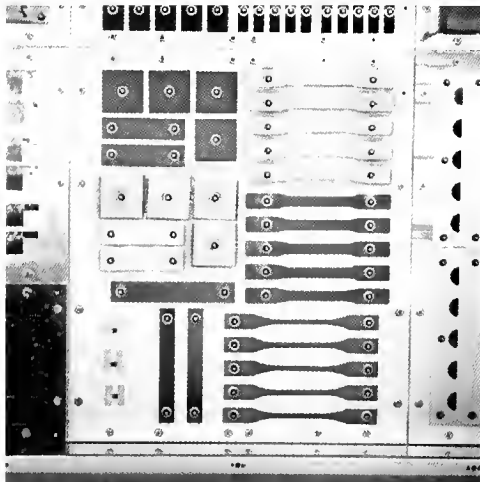
Figure 117 (Postflight). This close-up of Plate V in the lower center one-sixth of the tray shows that all specimens, including the tape holding down the small specimens in the lower left corner, have darkened significantly.

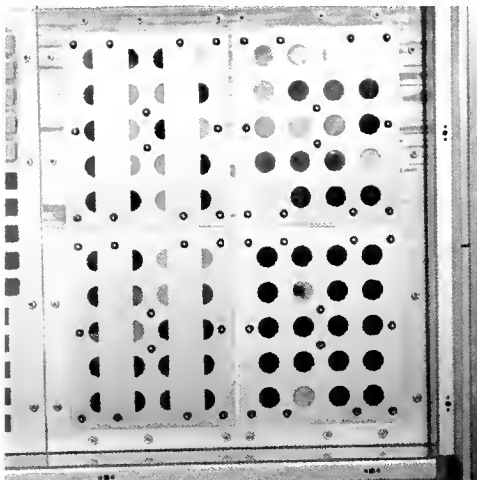
Figure 118 (Postflight). In this close-up of the lower right one-sixth of the tray, several of the coatings appear to have darkened and a unique pattern of light brown discoloration appears around the outer edges of the mounting plate and along the lower edge of the coverplates.

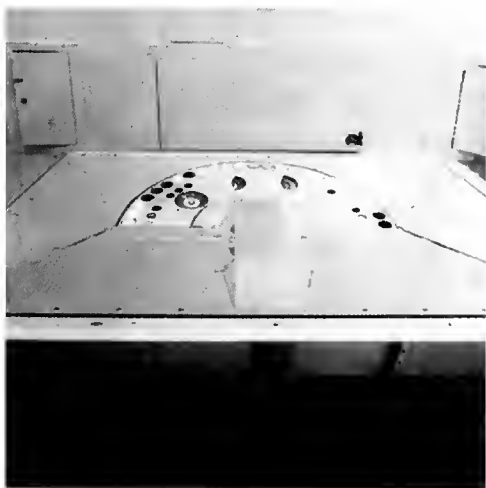
Figure 119 (Preflight). Experiment S0069 was self-contained: it included power, a data system, a reflectometer, and a preprogrammed controller for automatically exposing, monitoring, and measuring the sample materials. Experiment S0069 had 25 active and 24 passive samples mounted in a semicircular pattern (active samples on the outer radius and passive samples on the inner radius) on a circular carousel. This arrangement maximized the exposure of the samples to the combined space environment. Three radiometers were located on the innermost radius. The photograph shows the carousel rotated to the open position. The thermal shroud has an outside exposed surface covered with 2-mil silvered Teflon film bonded with an adhesive.

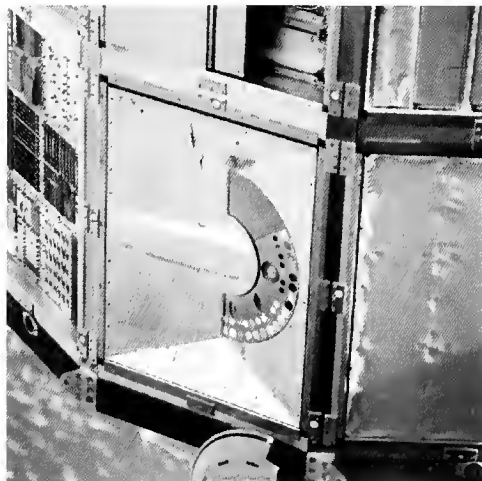
Figure 120
Photo No.: S32-76-005
Dup. Neg. No.: L90-10375
LISAR No.: EL-1994-00660
Photo Credit: JSC
Photo Date: 1/12/90
Location: In Flight
Subject: In-Flight Survey of Tray A9

Figure 120 (In Flight). Here, the original silver mirrorlike shroud surface appears white with copious amounts of a brown discoloration in a distinct pattern. The upper and lower triangular sections of the shroud have many irregular black discolorations and areas where the adhesive appears to have failed. Changes in color have occurred in both the active and the passive test samples. The three radiometers appear to have no physical damage.
